RENEWAL OF A CHLORIDE-DAMEGED RC HOLLOW SLAB BRIDGE —MATSUSHIMA VIADUCT ON HANWA EXPRESSWAY—

Matsushima viaduct on Hanwa expressway has been experiencing severe deterioration on its structural health through over thirty years service. The superstructure is four-span RC continuous hollow slab and was overlaid with steel-fiber reinforced concrete in 1990 to meet the growing heavy traffic. Even after the reinforcement, the functionality of the bridge was lost rapidly by suffering from heavy traffic and chloride content that was contained initially and being supplied by wind from sea. Finally it was found that a drastic treatment must be executed on the bridge to reinforce the superstructure.

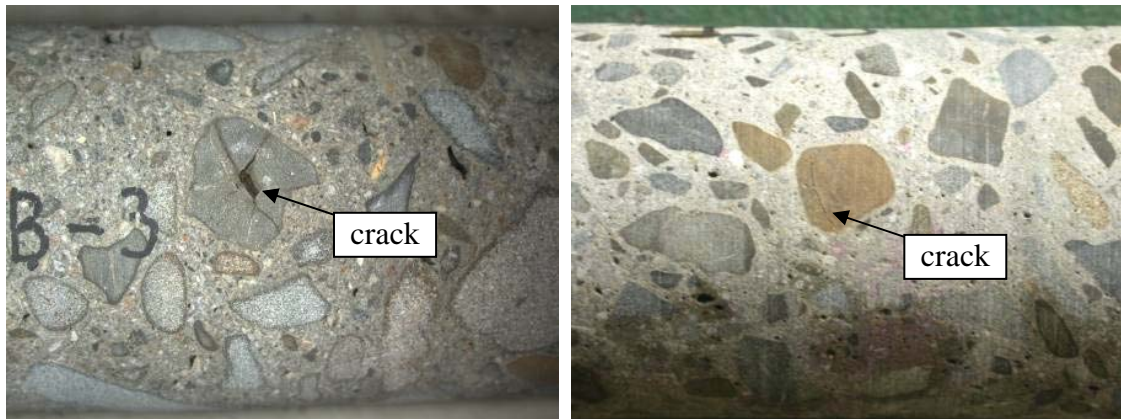
24N/mm² and 25kN/mm² respectively, and (3) delamination between the base concrete and overlay concrete was found in large area of the interface. The causes to weaken the strength of concrete were supposed to be micro cracks between cement and aggregates or inside of aggregates, and they were observed as shown in Fig. 2. The delamination along with the upper distribution reinforcing steel bars and deterioration of steel bars caused by macro-cell reaction were also observed as shown in Fig.3, and specially the cracks in the slab were considered to be considerably detrimental (Fig.4.), while the corrosion of steel bars were not so urgent, but countermeasures must have been introduced in this construction. The degree of ASR (Alkali-silica reaction) was also tested and it was not so serious with the result of 248 μ comparing to 1000 μ . Cracks of with length of more than 1,400m were found at the lower side of slab and the results of loading tests with vehicles of weight 391.6 kN were compared with structural analysis and other bridges with concluding that the deflections on mid-span were twice as large as structural analysis.

Fig.2 Crack in aggregates

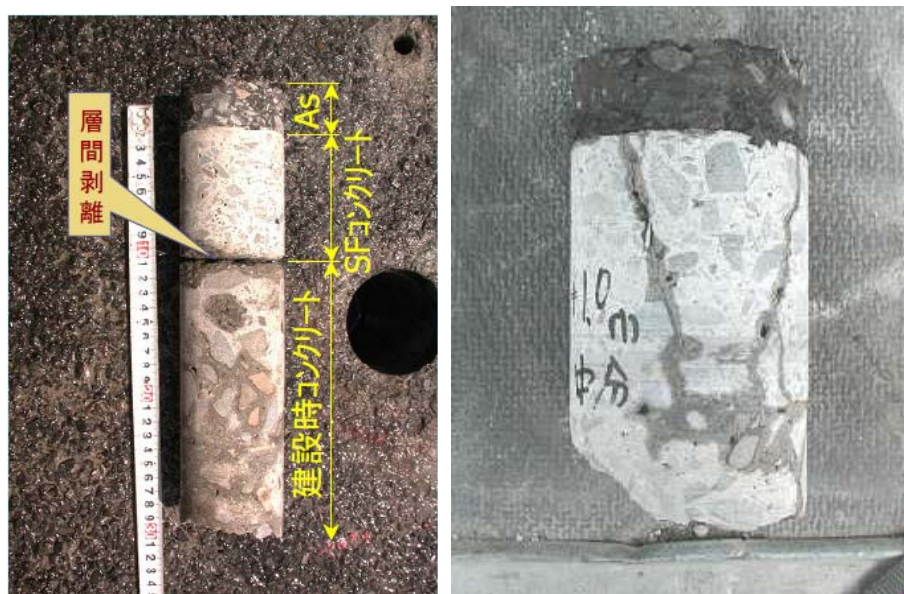
Fig. 4. Delamination and vertical cracks observed at core specimens

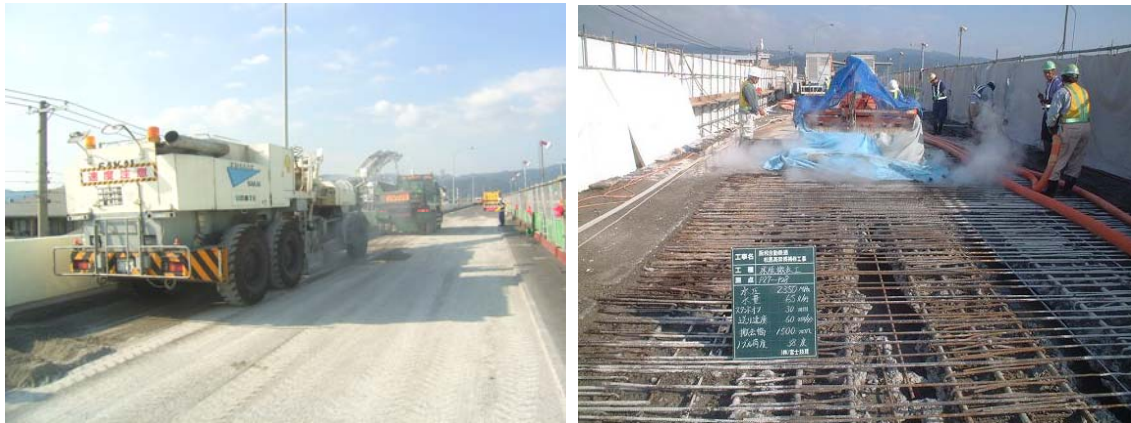
Fig. 6 Shaving (left) and Water-jet (Right)

The blue sheets and white panels shown in the right picture of Fig. 6 were used to lower the sound level and avoid splashing into traffic. Through construction, two lanes were always open for traffic and it has been done without accidents or injury.

As this bridge is supporting the lanes of a ramp connecting to other roads, closing traffic of the ramp was avoided and traffic control should have been minimized. The design period of traffic control of the partial replacement plan was two months shorter than the whole replacement plan, and the amount of concrete removed to be industrial waste was 40% smaller, and the total cost was 15~20% lower, then the partial replacement plan was adopted. The design of cross section to be constructed is shown in Fig. 5. Shaving machine which has high ability to remove concrete and costs low and water-jet which has low ability to remove concrete and costs high were used. As shaving machine usually introduce micro cracks inside concrete, top 50mm of concrete was removed by shaving machine and water-jet was used to remove the initial slab to avoid micro cracks inside slab (Fig.6). This also made the total cost cheaper.

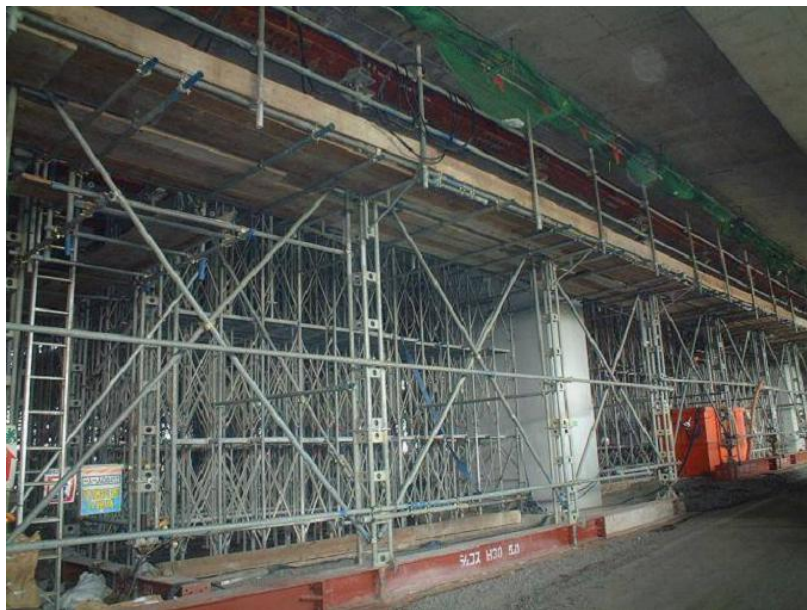
Fig. 7. Temporal supports

Analyzing the structure for each step of construction, it was concerned that cracks would be introduced into slab by relaxing steel bars. Therefore, during removing and placing concrete, whole slab was supported temporally (Fig. 7) and upper bars on supports were kept in non-stressed condition by jacking up to prevent cracking in slab.
